COUNTRY East Germany

SUBJECT Installations in the Eggesin Area

Appendix "A"

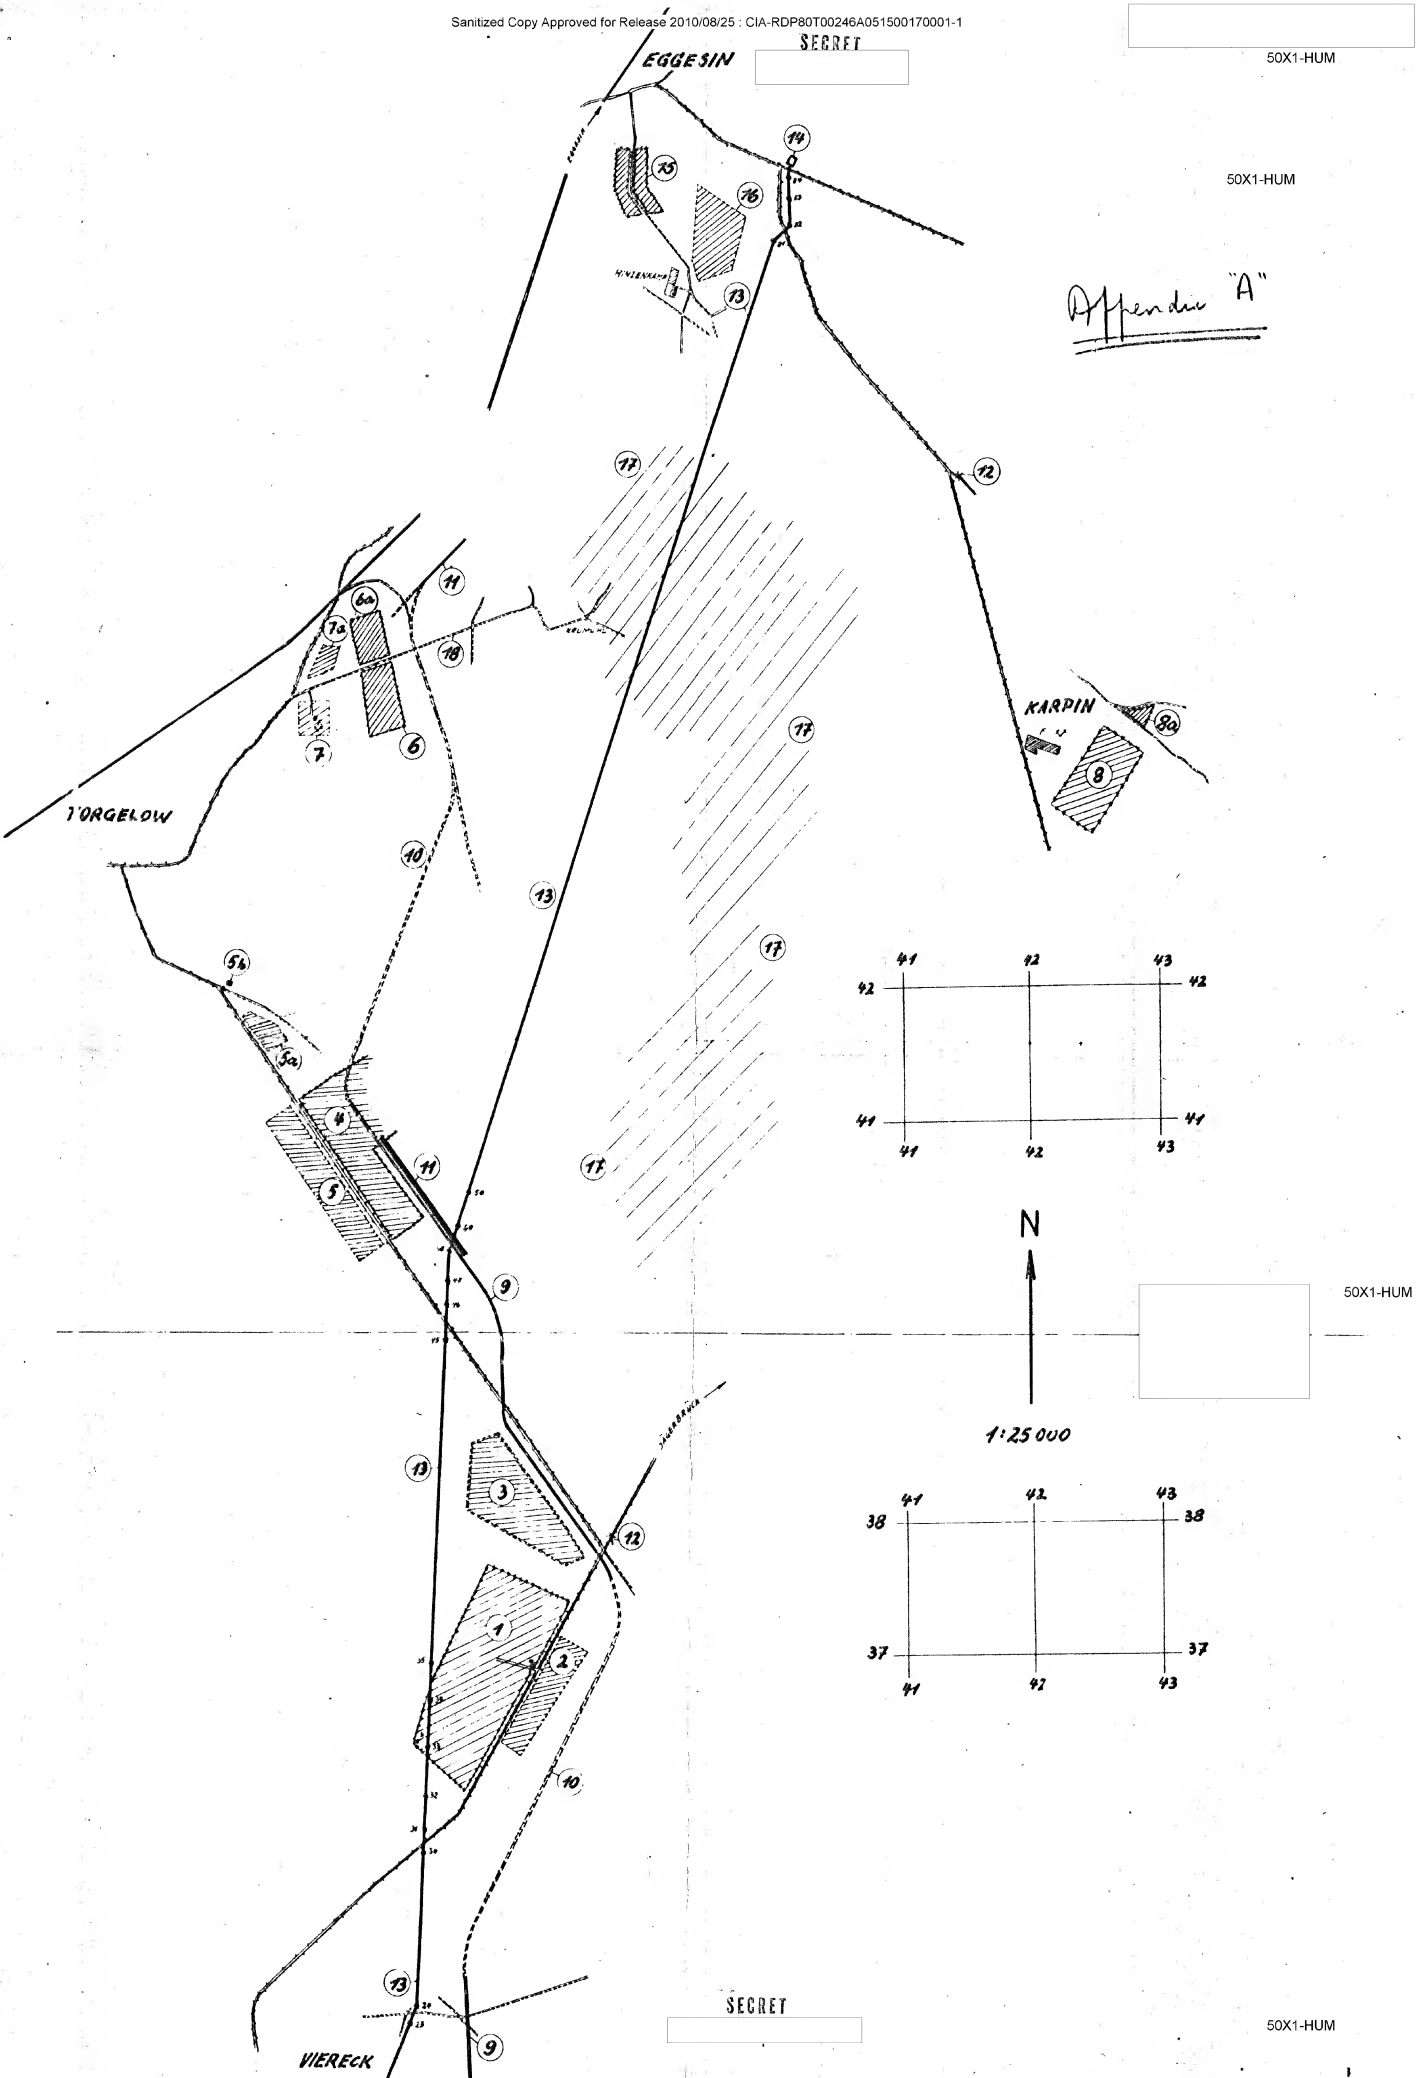
showing the position of barracks and installations in the area bounded by Eggesin, Torgelow, Karpin and Viereck. 50X1-HUM
2. Marked as No. 1 on the sketch is the Stallberg Barracks

Torgelow. It has at least 10 to 14 two-story barrack buildings of stone. At least six of these run parallel with and immediately along the west side of the road to Jägerbrück. The remaining buildings, of the same type, lie further west within the barracks area. Yet further west within the barracks area are administrative buildings, garages, workshops and a building used as a fire brigade headquarters.

3. Marked as No. 2 on the sketch is a colony of some 40 to 60 family houses for East German Army officers. Each house takes two families. The colony is laid out in development style, all the houses are identical, and it is not fenced-in. Among the houses are HQ shops for the use of the families.

4. Marked as No. 3 on the sketch is an ammunition dump. The area is difficult to penetrate or observe as it is heavily overgrown with trees and bushes. At least parts of it are fenced-in with a double fence. Scattered over the area are earthworks with ventilation pipes protruding from them. 50X1-HUM

5. Marked as No. 4 on the sketch is the Droegerheide Barracks

, Torgelow. There are at least 10 to 14 two-story stone barrack buildings. In the north-east of the barracks area are administrative buildings, garages and workshops.

6. Marked as No. 5 on the sketch is a colony of some 25 to 30 family houses occupied by East German Army officers and families. There are a number of HQ shops for the use of residents and also a number of huts and dumps of materials belonging to some Bau-Union. A HQ inn which was formerly located here and served as an East German Army officers' club was pulled down some months ago and re-erected at a point further northwest (marked No. 5b on the sketch).

7. Marked as No. 5a on the sketch is another colony of some 50 houses, each capable of taking two families. All the houses are built in the same style and are occupied by East German Army officers and families.

8. Marked as Nos. 6 and 6a on the sketch is the Spechtberg Barracks  50X1-HUM  
Eggesin. That part of the barracks located south of the path (known locally as the Panzer Strasse, and marked as 18 on the sketch) contains at least 12 two-story stone buildings and a number of smaller ancillary buildings.

9. The part of the barracks located north of the road and marked 6a on the sketch is considerably smaller and contains only 3 to 4 barrack buildings.
10. Marked as Nos. 7 and 7a on the sketch are colonies of family houses for East German Army officers and families. Each colony contains 40 to 50 houses and they are fenced-in. Spechtberg ranger's house (Försterei) is one of the houses and can in no way be distinguished from the others.

11. Marked as No. 8 on the sketch is Object Karpin  50X1-HUM  
located some 200 m. southeast of Karpin forest house.
12. Marked as No. 8a on the sketch is an ammunition dump. It lies within the corner made by the junction of two paths and is surrounded by a double fence. From the junction of the two paths it runs northeast and southeast for about 100 m. and is guarded by East German Army sentries. Earthworks, from which ventilation pipes protrude, are scattered within the dump area. 50X1-HUM

13. Marked as No. 15 on the sketch is the barracks known locally as Object Eggesin   
The barracks lies on both sides of the Eggesin - Hinzenkamp road. On each side of the road are about 10 two-story stone barrack buildings. Neither of the two barracks areas is fenced-in.

14. Marked as No. 16 on the sketch is Eggesin firing range. It lies immediately to the north of Hinzenkamp and is used as a range for small arms. Target ranges for rifles, machine guns and pistols are laid out.

15. Marked as No. 17 on the sketch is a large training area used by East German Army troops. Tanks use the area for firing and driving practice.
16. Marked as No. 18 on the sketch is the path known locally as the Panzer Strasse. It is a sand path and runs from the Torgelow - Eggesin road to Neumühl. It is not closed to civilian traffic, but has been so damaged by tanks and is so rutted and torn up that it is now almost impassable for ordinary traffic. 50X1-HUM
